R-585-4-4-31
PRELIMINARY ASSESSMENT OF
ALLIED CHEMICAL CO. - HOPEWELL PLANT
PREPARED UNDER

TDD NO. F3-8402-21
EPA NO. VA-40
CONTRACT NO. 68-01-6699

JULY 16, 1984

NUS CORPORATION
SUPERFUND DIVISION

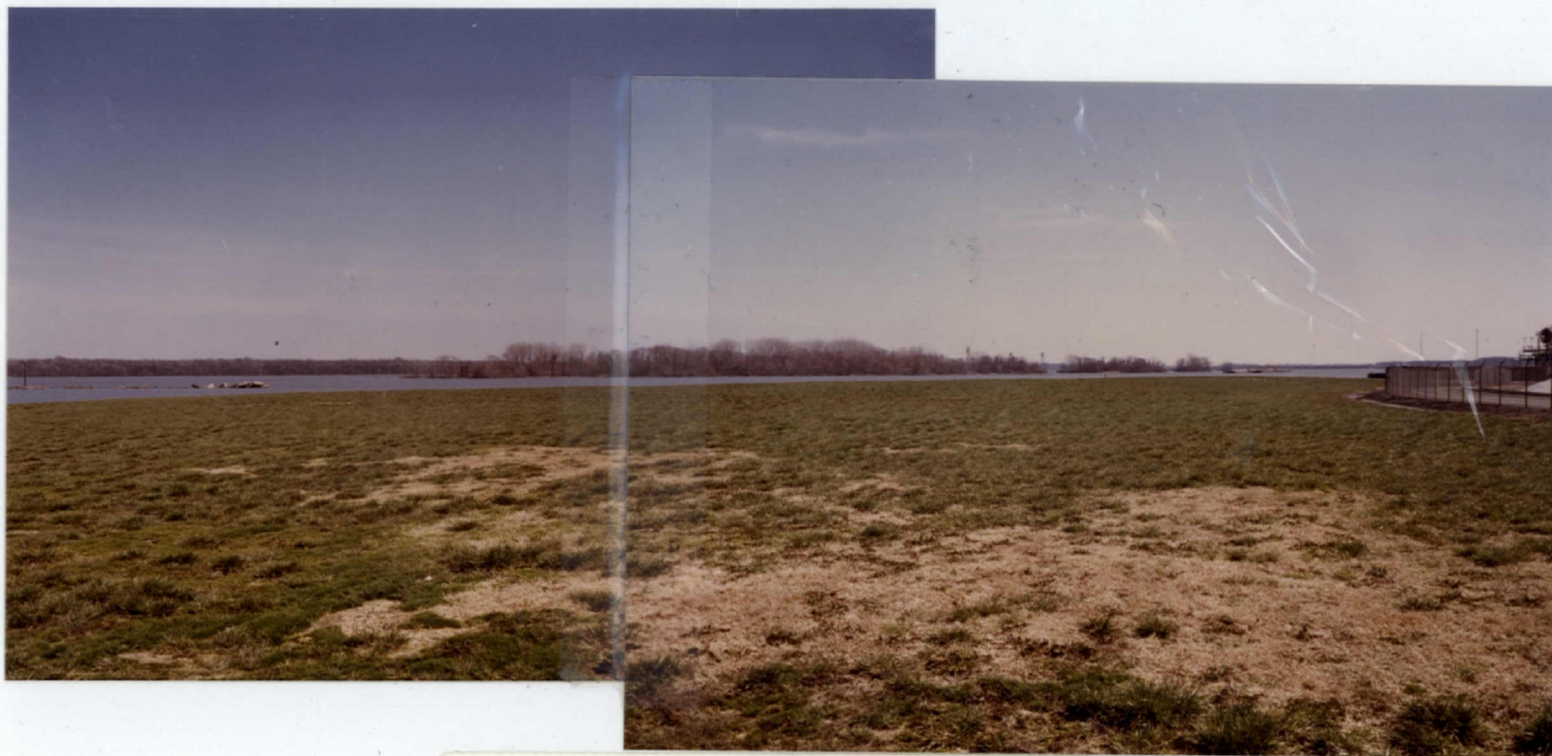
- o The dredge spoil area, located along the northern portion of the facility, was observed to be about 1 to 2 acres in size and completely grassed over. The area is bordered by the James River. Leachate was not observed on or leaving the site.

Photos 1-2 - Panoramic view of
dredge spoil disposal area. Photo
looking northeast.

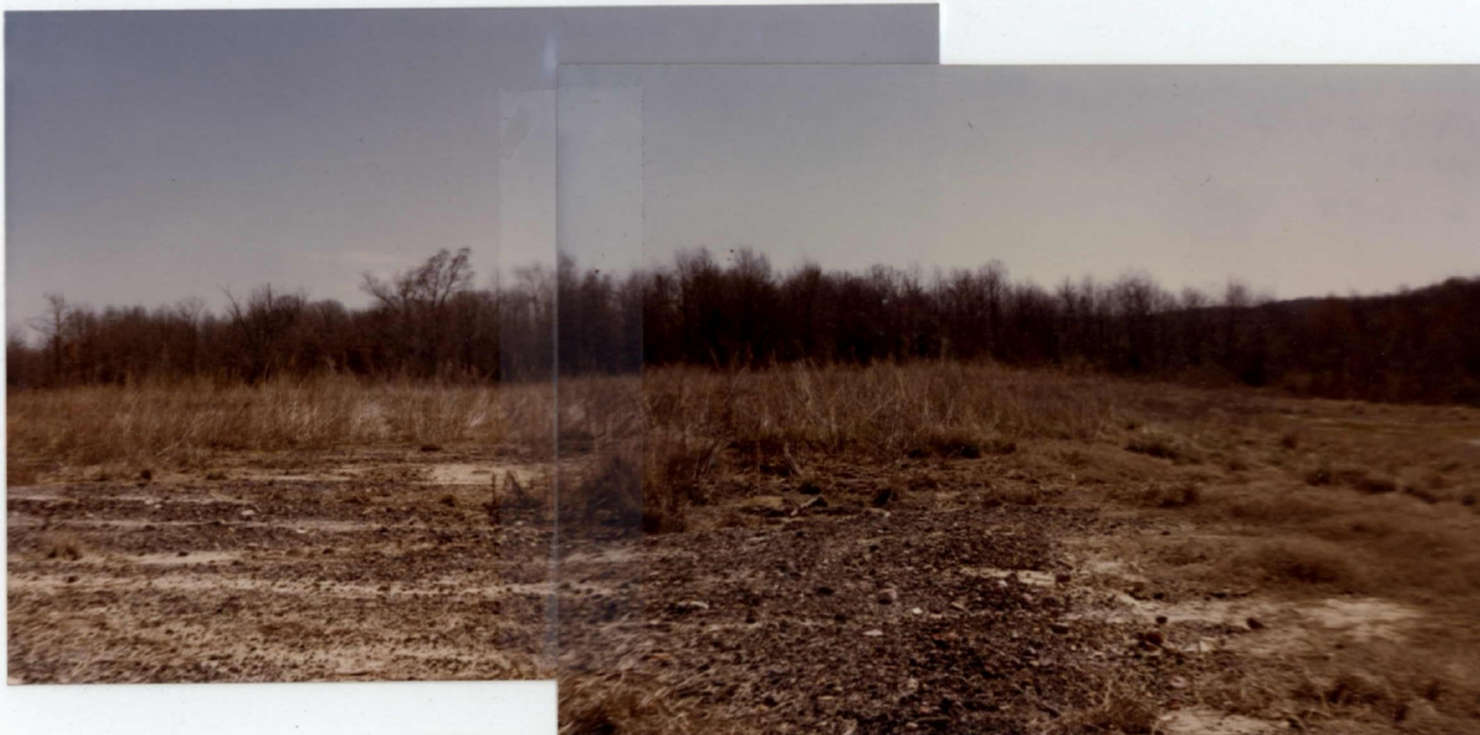
- o The old phenol residue ponds were filled in with rocks and soil and partially weeded over. The defined boundaries of these ponds could not be determined. The exact depth of the ponds and the amount of fill material deposited are unknown; however, it was reported that the ponds were originally about 8 feet deep. Leachate and ponded water were not observed in this area. These ponds are located off Route 10, southeast of the main gate. Wooded areas were observed to the east, north, and west of these ponds.

— Photo 3-4 - Panoramic view of former
— location of plenol residue ponds. —
— Photo looking east. —

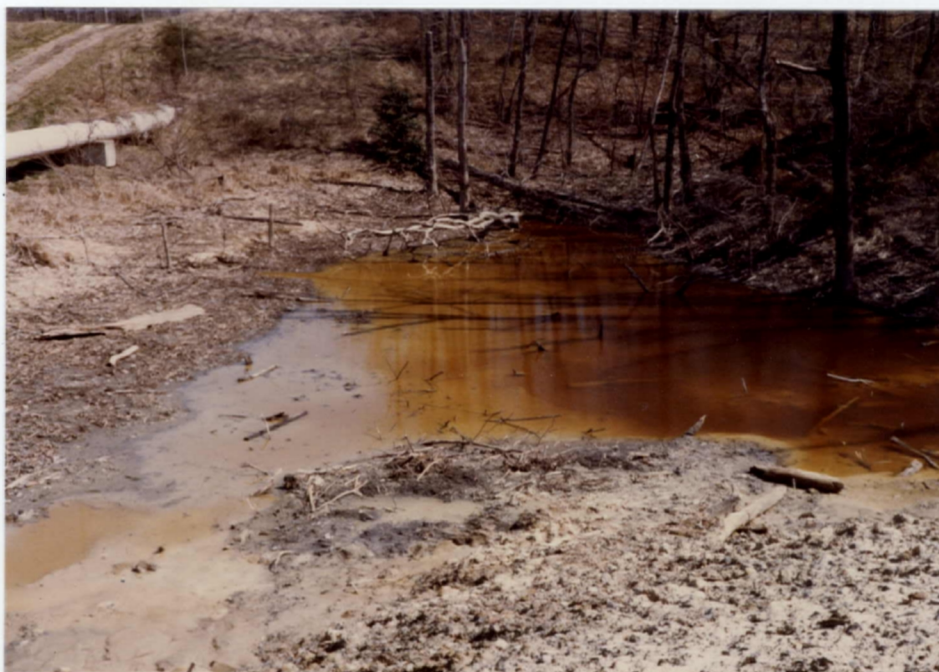
- o Two areas of ponded water were observed near the kepone landfill cell. These ponds were separated by a small access road off Route 10. The water in one pond was dark brown in color and about 2 to 8 feet deep. This pond is at the base of a small ravine adjacent to an old debris and rubble disposal area. This area is presently being filled. The water in the pond is primarily from precipitation, but a spring reportedly exists above the pond and may flow into the pond, as indicated by a drainage pattern in the ravine. When the water level in the pond rises, it discharges to Gravelly Run via a small cement culvert. Water was not observed entering or leaving the pond during the site visit.

— Photo 5 - Poned water area on east —
 — side of access road. Photo looking —
 — east. —
 — ORIGINAL (Red) —

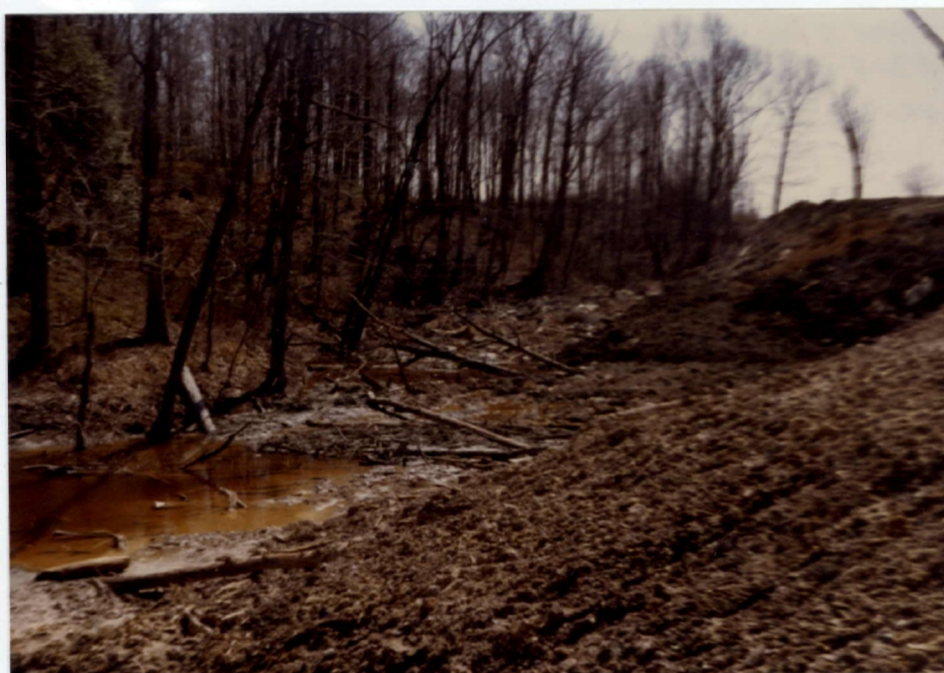
— Photo 6 - Debris and rubble disposal —
 — area near ponded water. Photo looking —
 — south. —

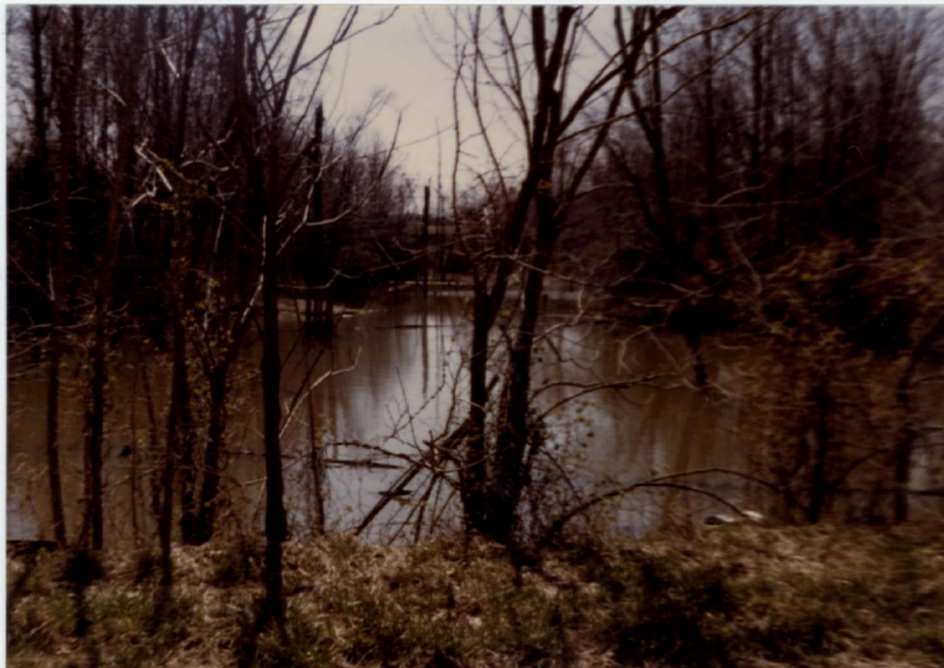
The pond on the opposite side of the road was larger, with water depths ranging between 3 and 5 feet. Trees and other vegetation were observed growing in this pond, and the water was relatively clear. According to Allied officials, this pond contains snakes and frogs during the warmer months. The source of water for this pond is precipitation, and the water level drops during dry weather. This pond is connected to Gravelly Run by a cement culvert.

— Photo 7 - Ponded water on west side —
— of access road. Photo looking south. —
— ORIGINAL (Red) —

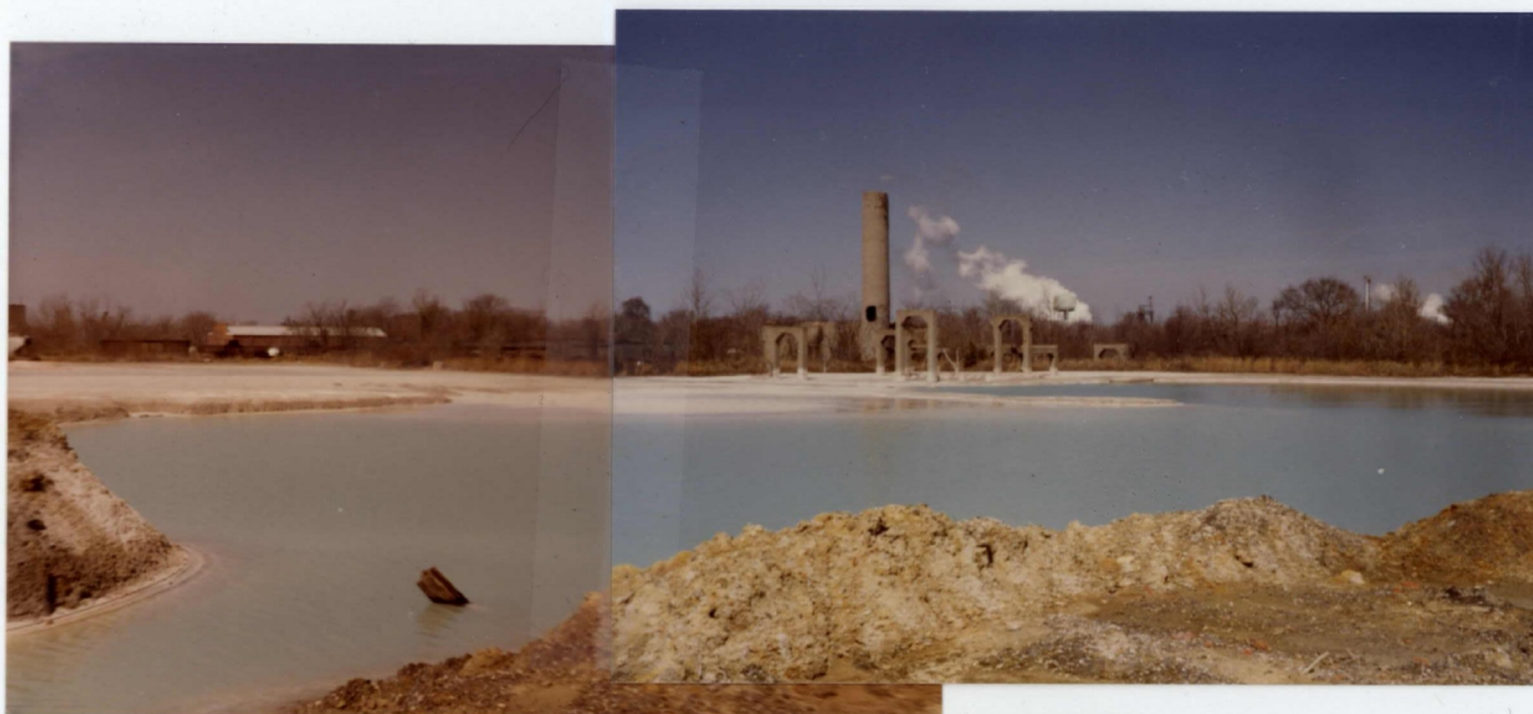
- o An old inactive alum mud lagoon was observed on Allied's Alum Plant property, located south of Route 10 off the Hopewell Plant property. The water in the lagoon was bluish-green in color, and its depth could not be determined. Water was not observed entering or leaving the lagoon which was surrounded by a white powdery material. According to Allied officials, the source of water in the lagoon is precipitation.

Photo 8-9 - Panoramic view of old
alum mud lagoon, Allied Alum Plant.
Photo looking northeast.

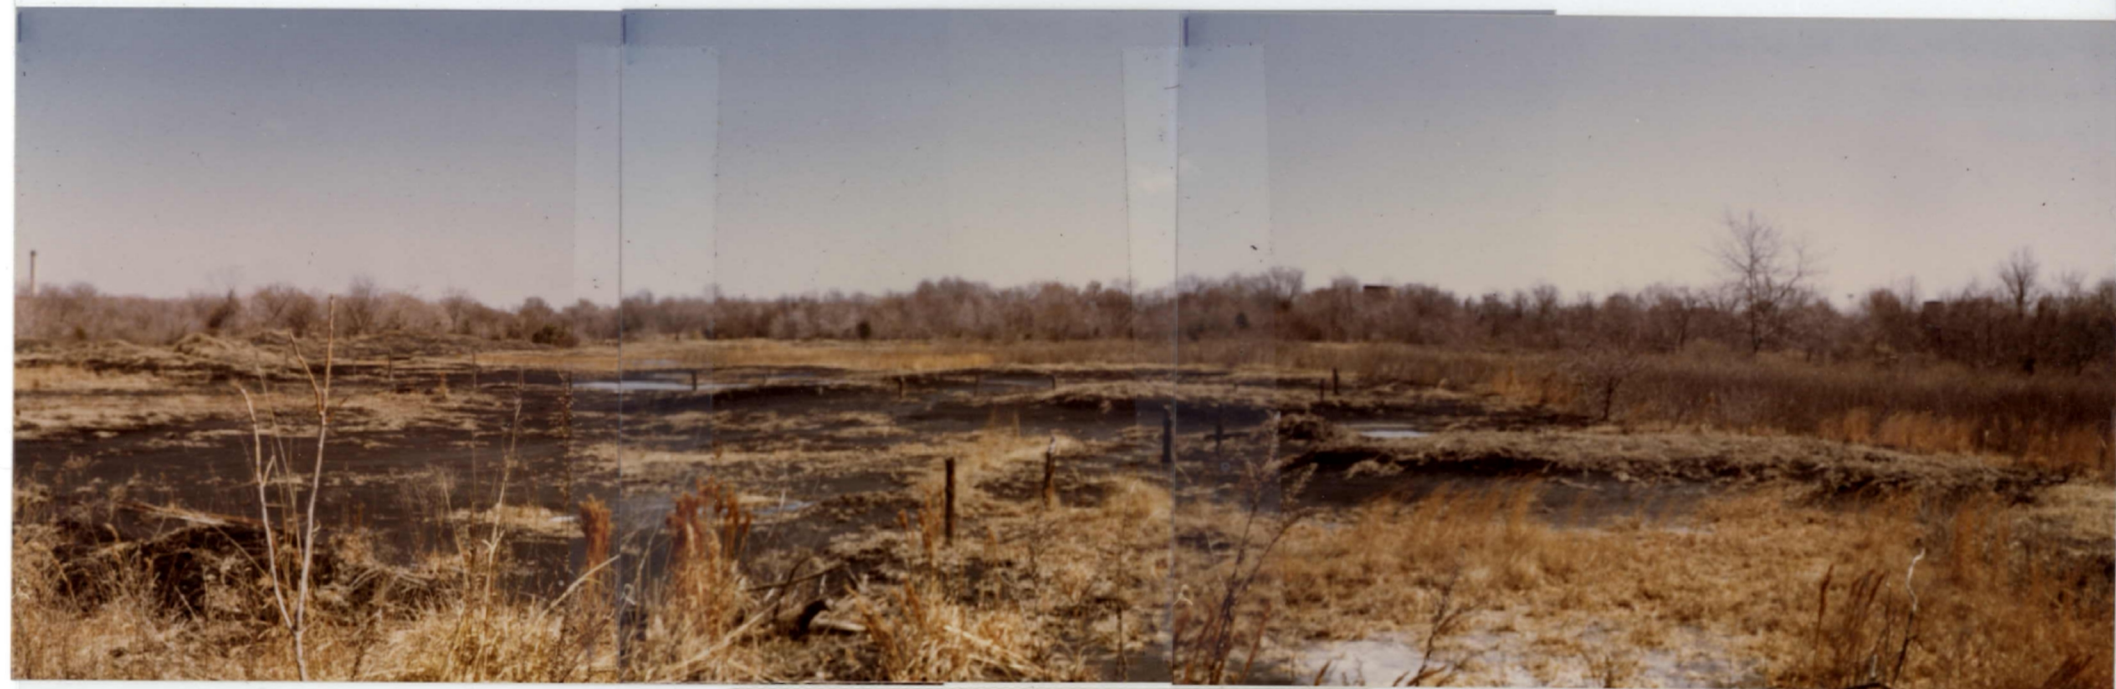
- o The fly ash field, located behind the alum lagoon, was observed to be greater than 20 acres in size and was partially weeded over. Fly ash covered the surface of this area. Several large areas of ponded water were also observed. This field was reportedly used as a settling area for activated carbon treated water generated during the decontamination of the Semi Works Plant. A network of hoses, used to transport the water, was observed on the landfill's surface. Allied officials stated that these hoses would be removed in the near future.

Photo 10-12 - Panoramic view of fly-
ash field located behind alum mud
lagoon. Photo looking south.

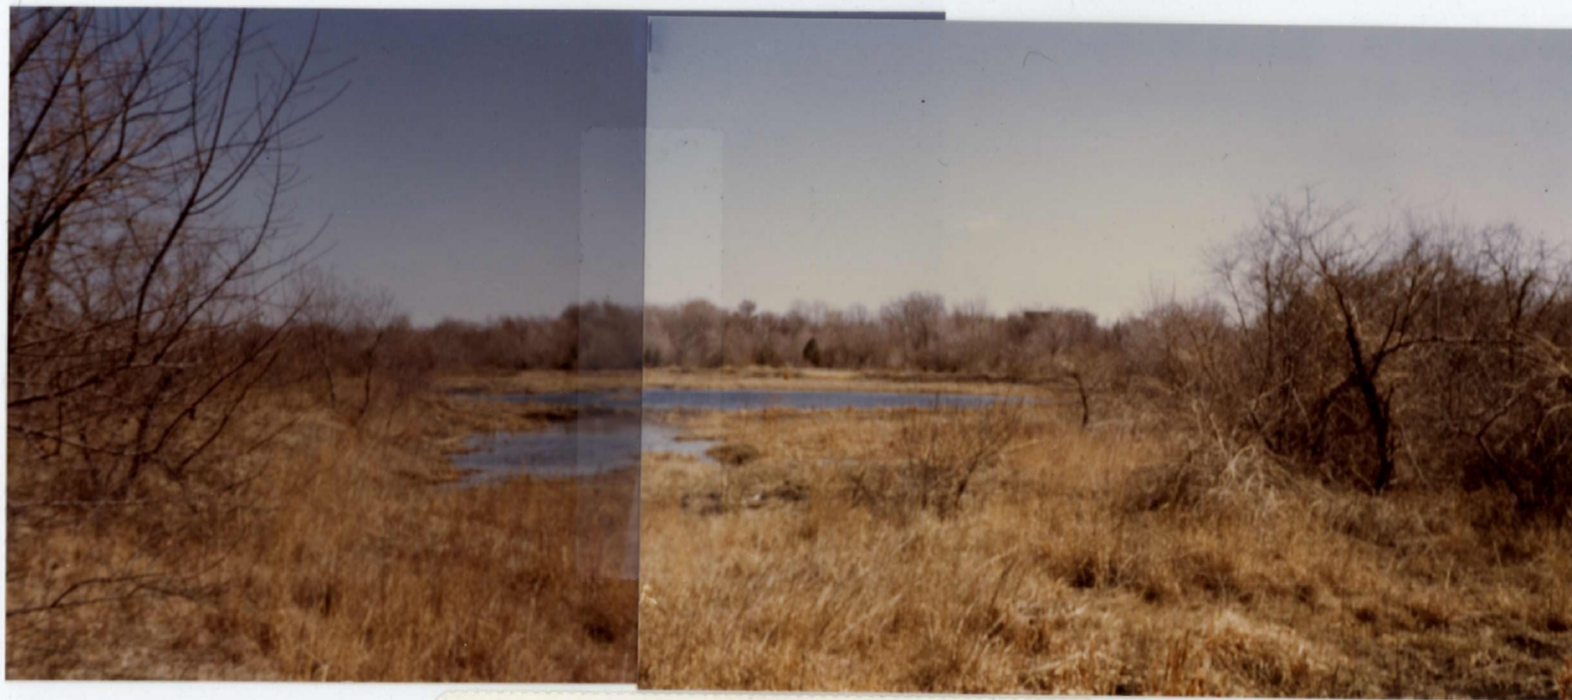
Photo 13-14 - Ponded water area on
flyash field. Photo looking south-
west.

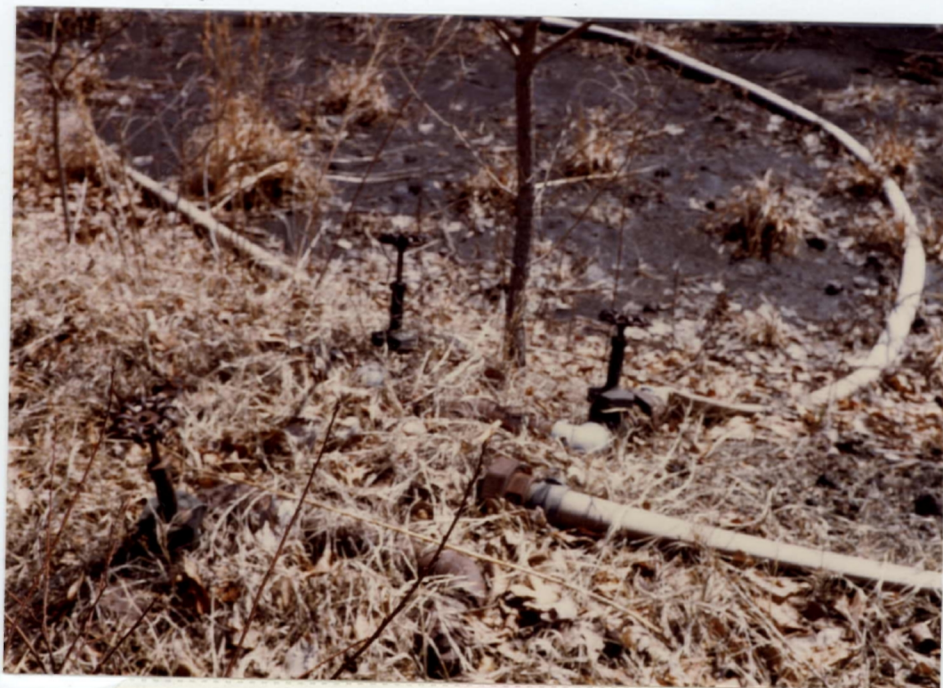
— Photo 15 - Photo of ~~ORANGE~~ valve and hosing —
— network used to transport decontamina —
— tion water to flyash field. —
